Maryland Inventory of Historic Properties

MIHP Number: CARR-1283

Property Name: Robert A. Martin House

State Historic Sites Inventory Form

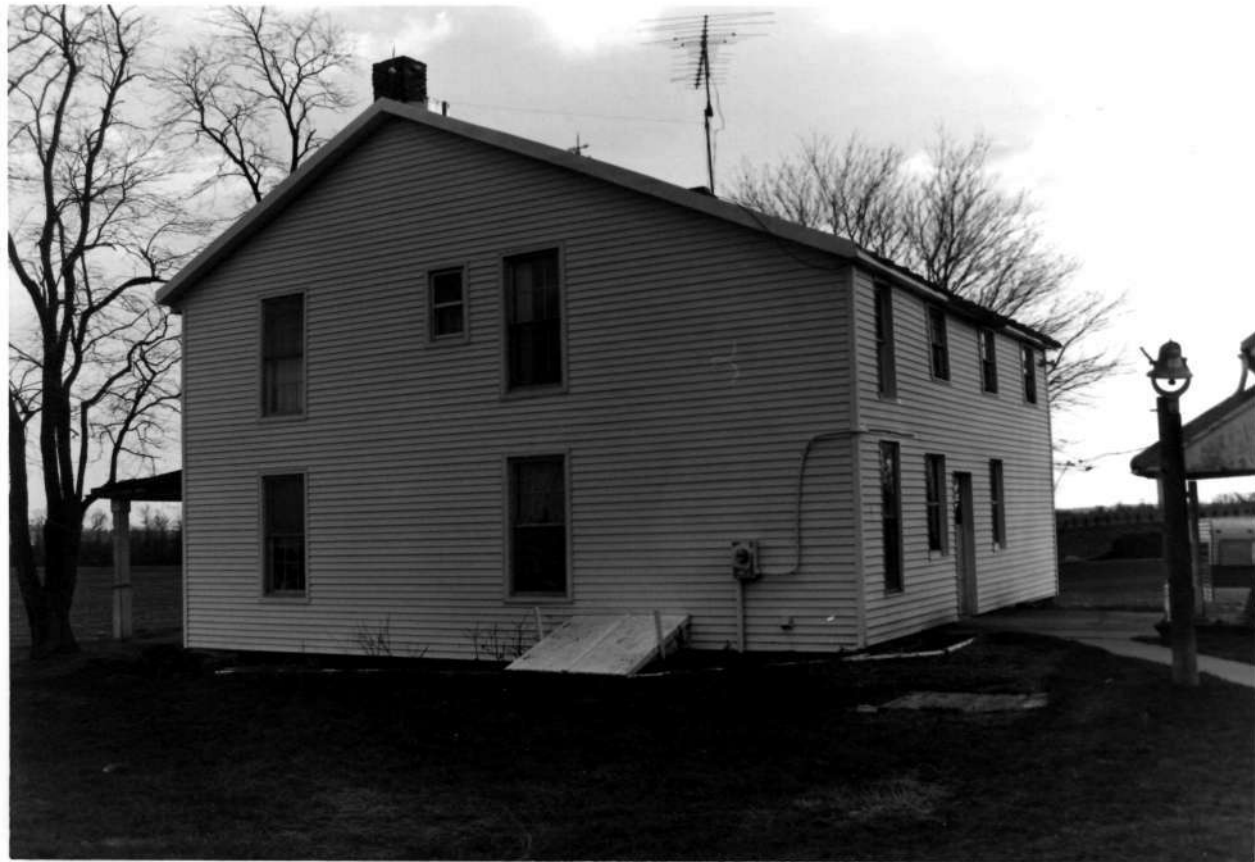
1. CARR-1283 ROBERT A. MARTIN HOUSE
2. Carroll County, Maryland
3. Joe Getty
4. November 1986
5. Md. Hist. Trust, Annapolis, Md.
6. E & N elev (camera fac sw)
7. 2/11

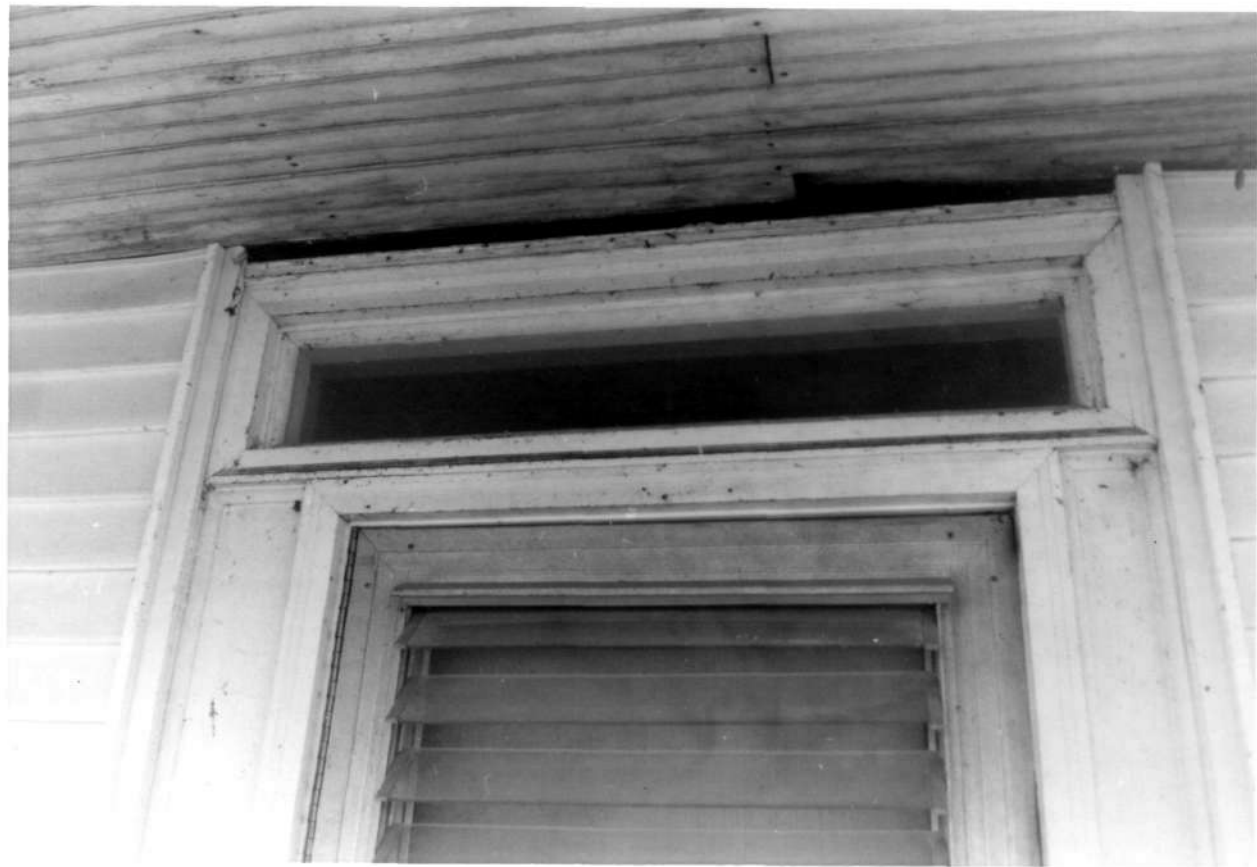
The three bay main facade faces south and has a central entrance. There is a full-length, one-story porch with a hipped roof supported by square posts. The central entrance has single pane transom but the door and side panels were recently installed by the present owner when the existing door blew down during a storm.

1. CARR-1283 ROBERT A. MARTIN HOUSE
2. Carroll County, Maryland
3. Joe Getty
4. September 1986
5. Md. Hist. Trust, Annapolis, Md
6. S elev. -- transom detail
7. 3/11

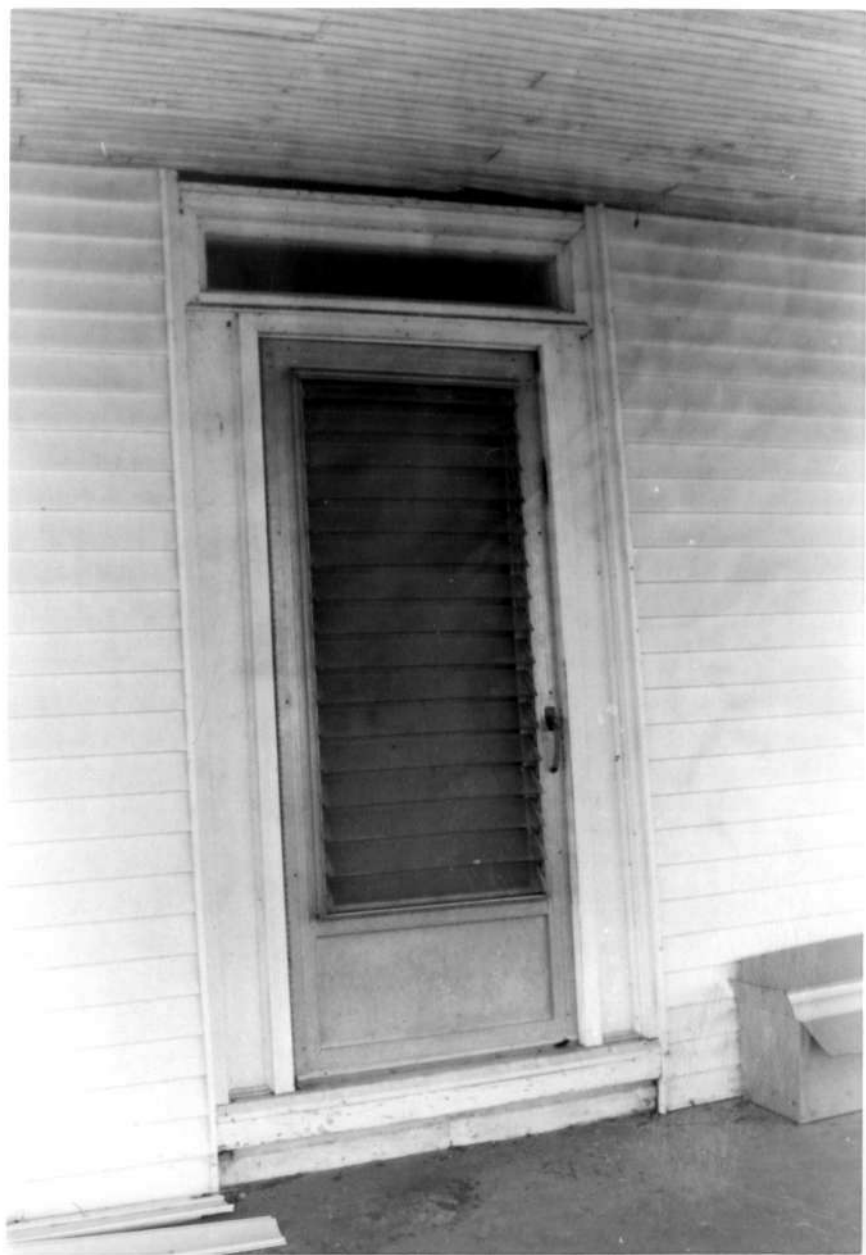
1. CARR-1283 ROBERT A. MARTIN HOUSE
2. Carroll County, Maryland
3. Joe Getty
4. September 1986
5. Md. Hist. Trust, Annapolis, Md.
6. S elev. -- front door
7. 4/11

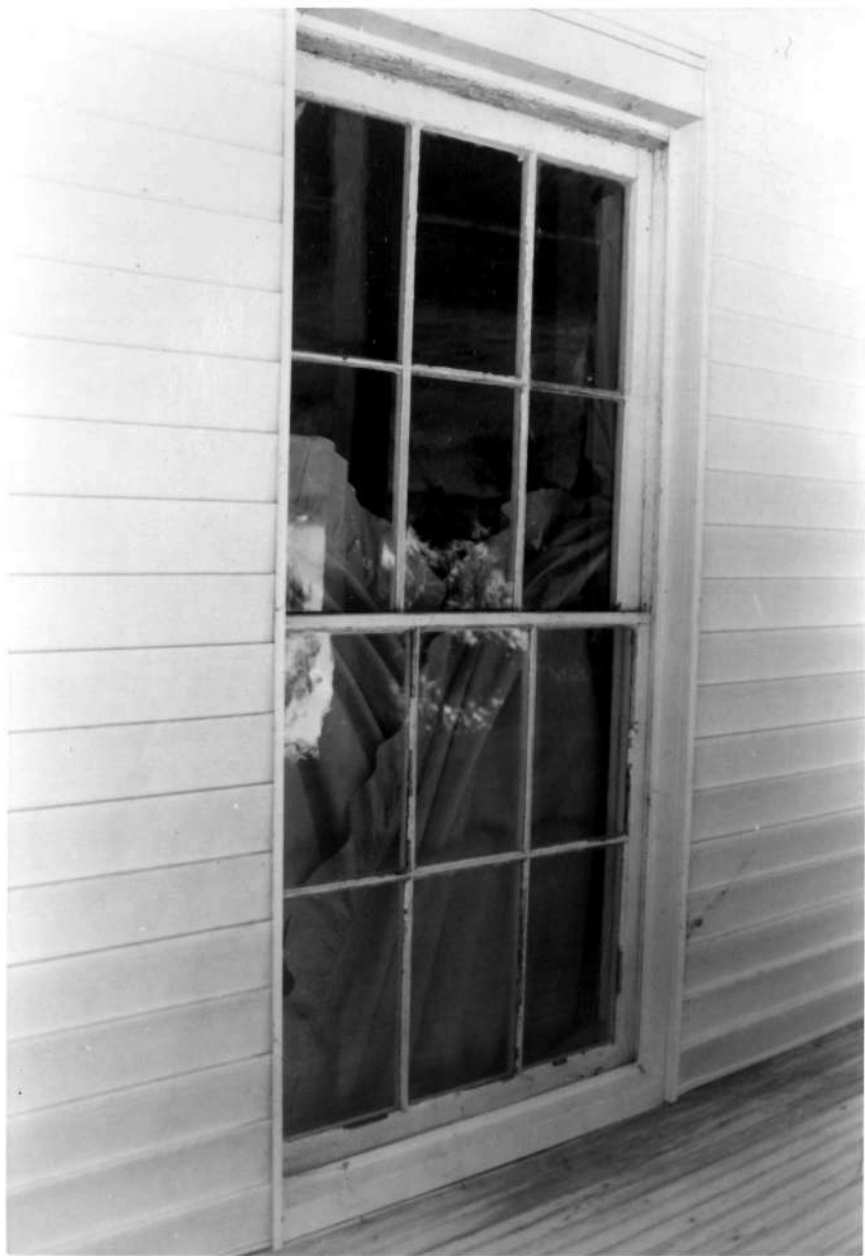
Other bays on the main facade and on the east and west gable ends have tall six-over-six sash windows. These windows are late 19th century in style and shape. The original wood frames are not exposed but are covered in aluminum siding.

1. CARR-1283 ROBERT A. MARTIN HOUSE
2. Carroll County, Maryland
3. Joe Getty
4. September 1986
5. Md. Hist. Trust, Annapolis, Md.
6. S elev -- window frame
7. 5/11

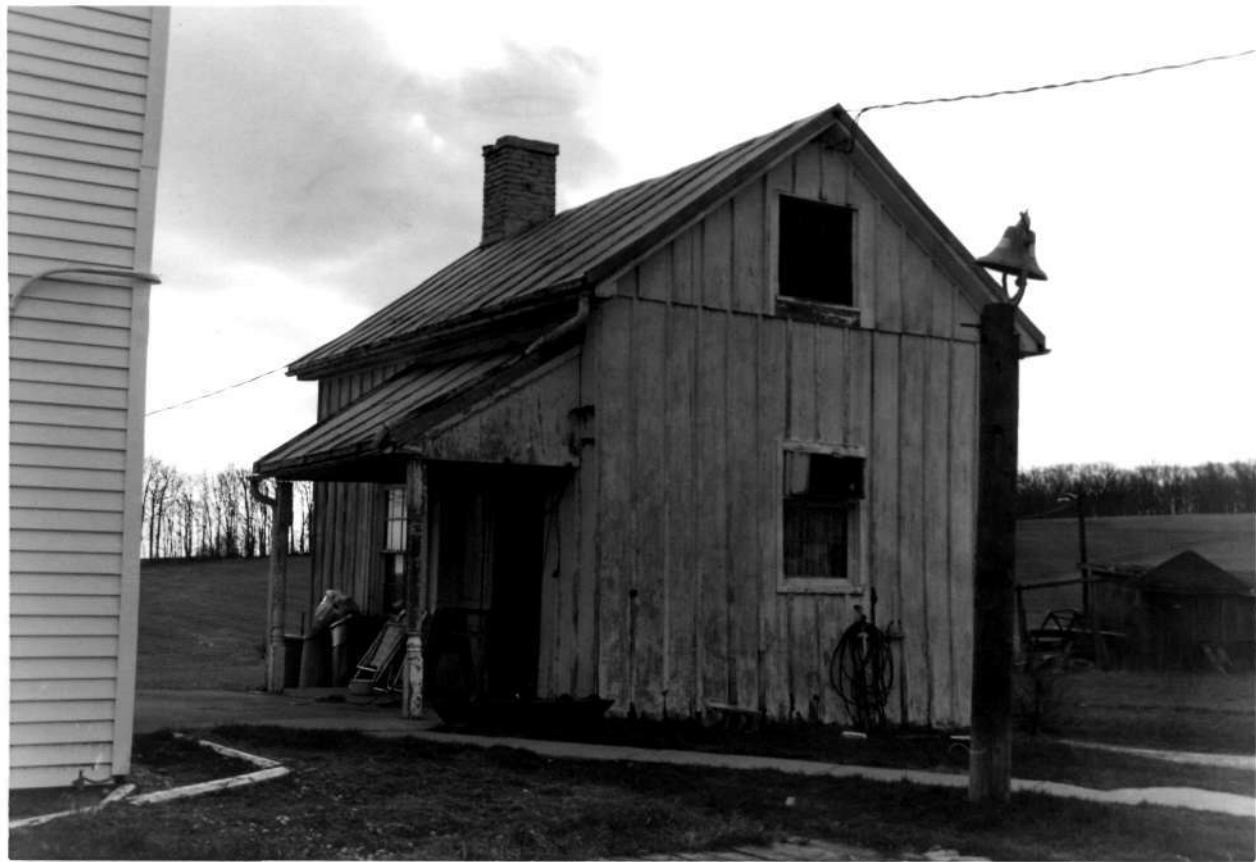
dimensions 14 X 20 feet. It is constructed of frame on a fieldstone foundation and has a gable roof covered in standing seam sheet metal. The south elevation faces the farmhouse and has a door, six-over-six window, and a one-story porch with shed roof. The east elevation has a three-over-six sash window and a six-pane window in the gable. The north elevation has a six-over-six sash window and the west elevation is unfenestrated. A brick chimney rises from the peak of the roof at the west gable end.

1. CARR-1283 ROBERT A. MARTIN HOUSE
2. Carroll County, Maryland
3. Joe Getty
4. November 1986
5. Md. Hist. Trust, Annapolis, Md.
6. Washhouse, s & e elev.
7. 6/11

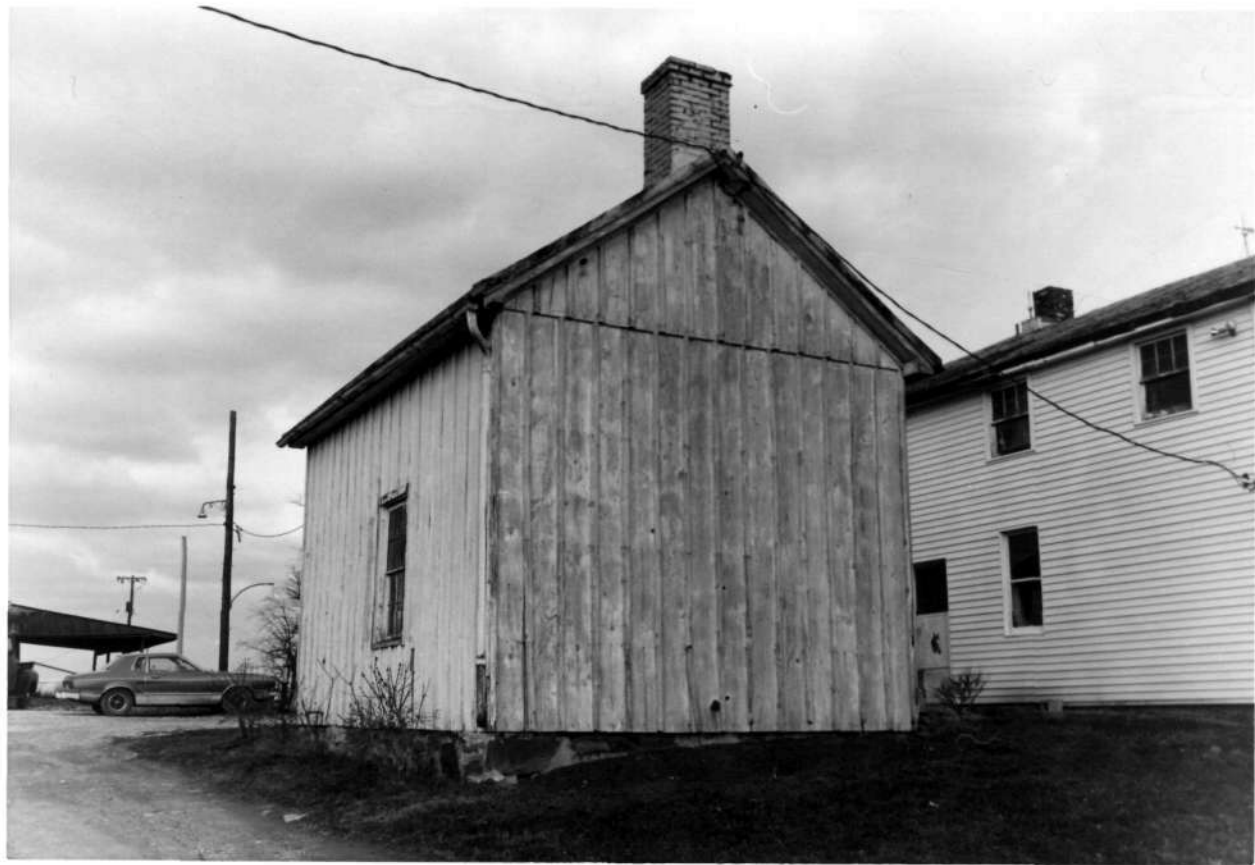
1. CARR-1283 ROBERT A. MARTIN HOUSE
2. Carroll County, Maryland
3. Joe Getty
4. November 1986
5. Md. Hist. Trust, Annapolis, Md.
6. Washhouse, n&w elev
7. 7/11

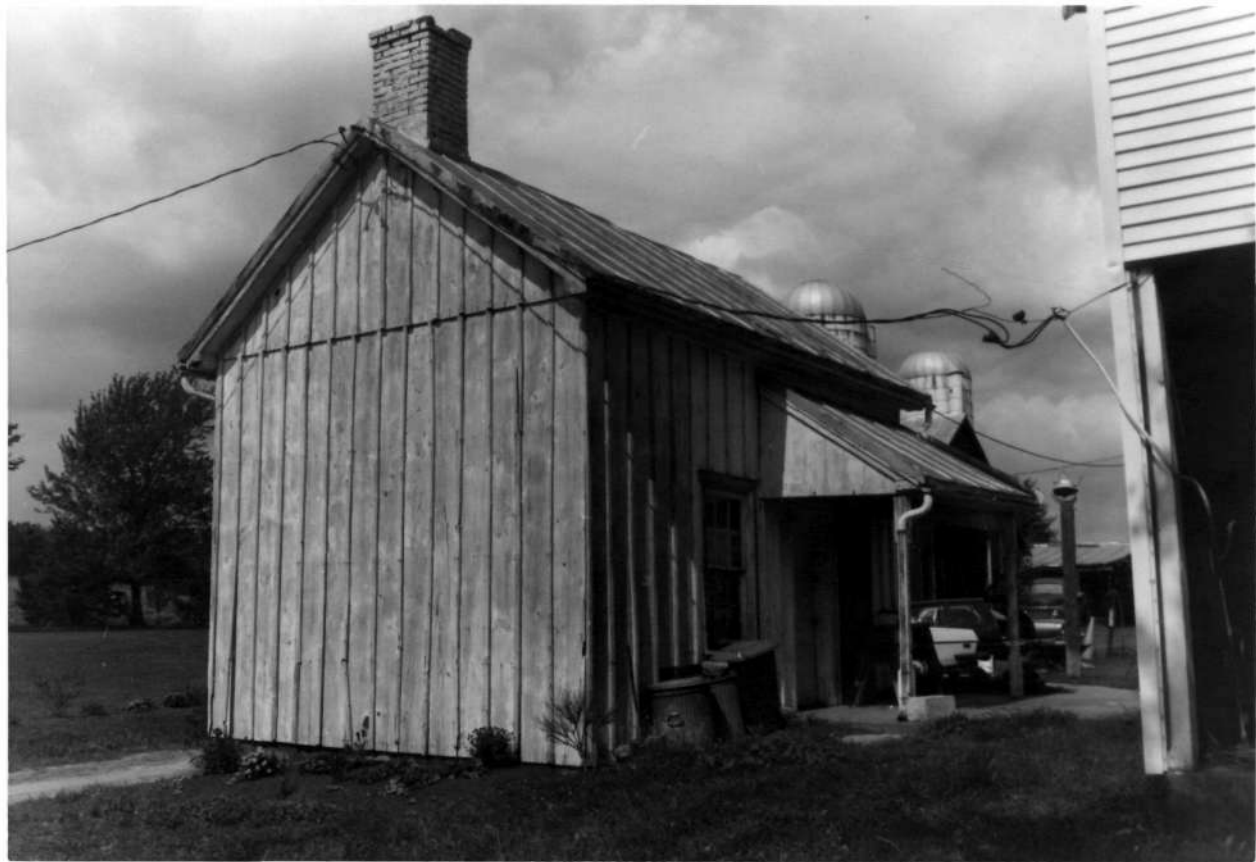
1. CARR-1283 ROBERT A. MARTIN HOUSE
2. Carroll County, Maryland
3. Joe Getty
4. September 1986
5. Md. Hist. Trust, Annapolis, Md.
6. Washhouse, S & w elev
7. 8/11

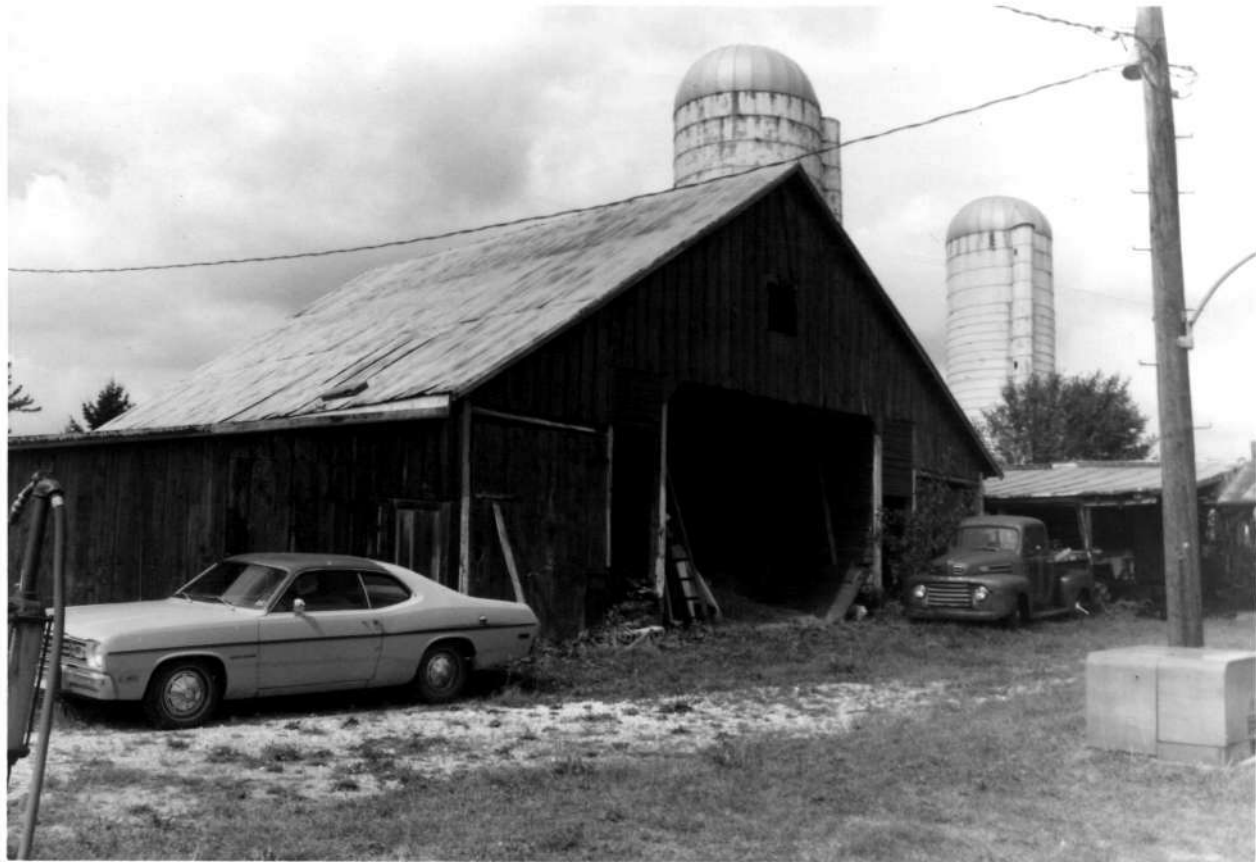
1. CARR-1283 ROBERT A. MARTIN HOUSE
2. Carroll County, Maryland
3. Joe Getty
4. September 1986
5. Md. Hist. Trust, Annapolis, Md
6. Wagon shed, S & w elev
7. 9/11

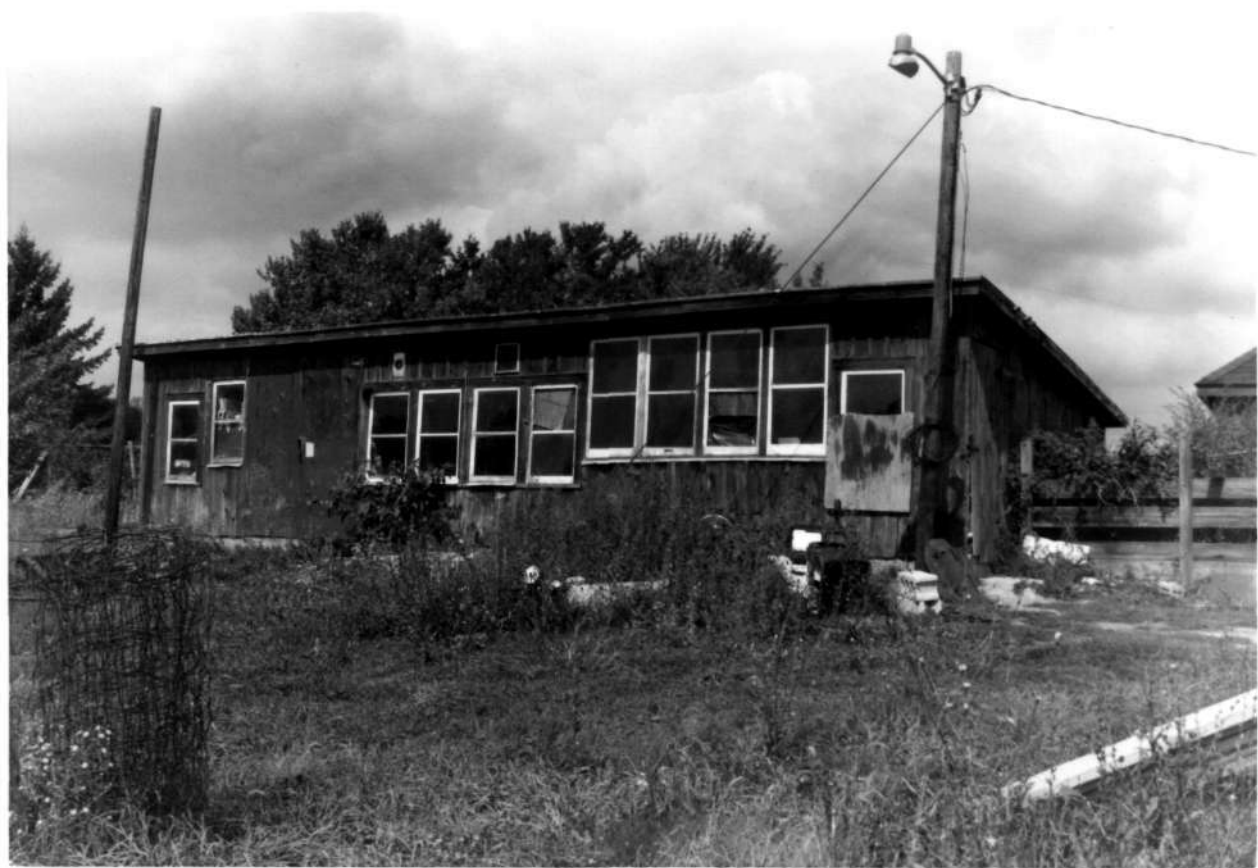
North of the washhouse is a small complex of domestic buildings. There is a frame chicken house with a shed roof. The windows of the chicken house, which face west, have been replaced. There is also a board-and-batten smokehouse built about 1975.

1. CARR-1283 ROBERT A. MARTIN HOUSE
2. Carroll County, Maryland
3. Joe Getty
4. September 1986
5. Md. Hist. Trust, Annapolis, Md.
6. Chicken house, W & S elev
7. 10/11

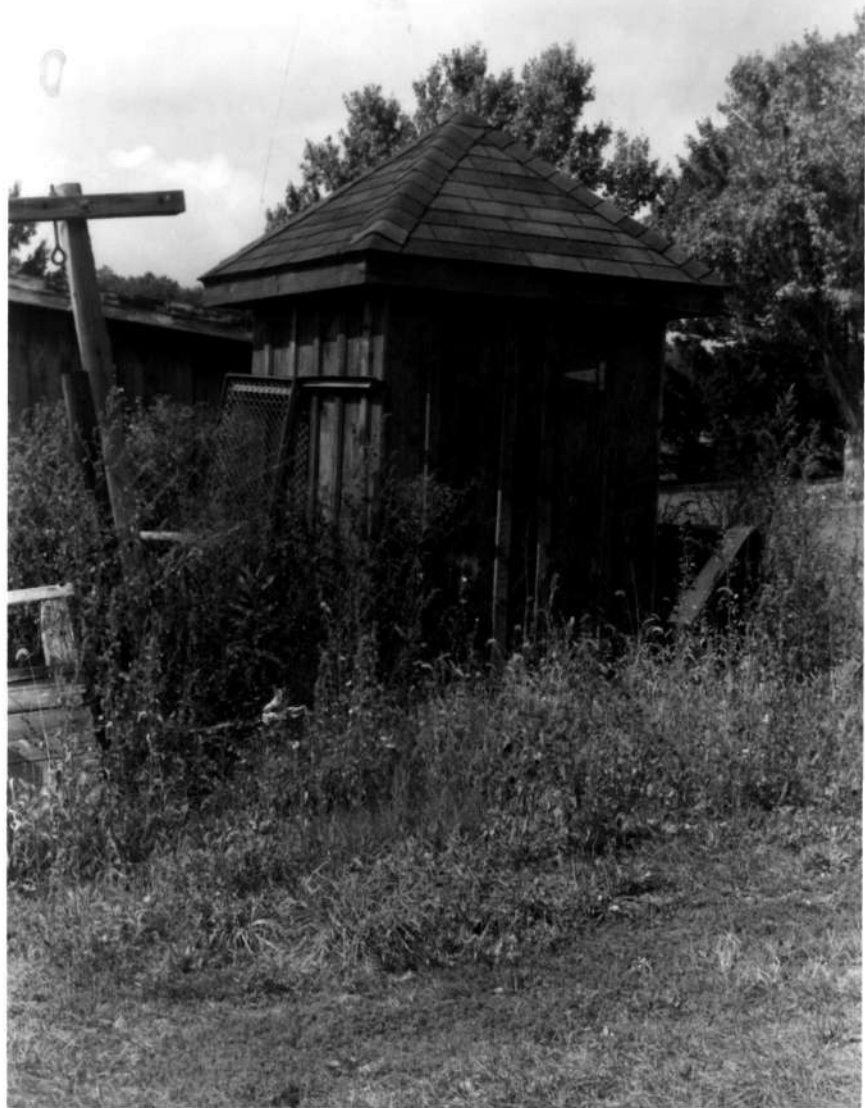
1. CARR-1283 ROBERT A. MARTIN HOUSE
2. Carroll County, Maryland
3. Joe Getty
4. September 1986
5. Md. Hist. Trust, Annapolis, Md.
6. Smokehouse, W & S elev
7. 11/11
